Fracture of Reduced-Diameter Zirconia Dental Implants Following Repeated Insertion

Purpose: Achievement of high insertion torque values indicating good primary stability is a goal during dental implant placement. The objective of this study was to evaluate whether or not two-piece implants made from zirconia ceramic may be damaged as a result of torque application. **Materials and Methods:** A total of 10 two-piece zirconia implants were repeatedly inserted into polyurethane foam material with increasing density and decreasing osteotomy size. The insertion torque applied was measured, and implants were checked for fractures by applying the fluorescent penetrant method. Weibull probability of failure was calculated based on the recorded insertion torque values. **Results:** Catastrophic failures could be seen in five of the implants from two different batches at insertion torques ranging from 46.0 to 70.5 Ncm, while the remaining implants (all belonging to one batch) survived. Weibull probability of failure seems to be low at the manufacturer-recommended maximum insertion torque of 35 Ncm. Chipping fractures at the thread tips as well as tool marks were the only otherwise observed

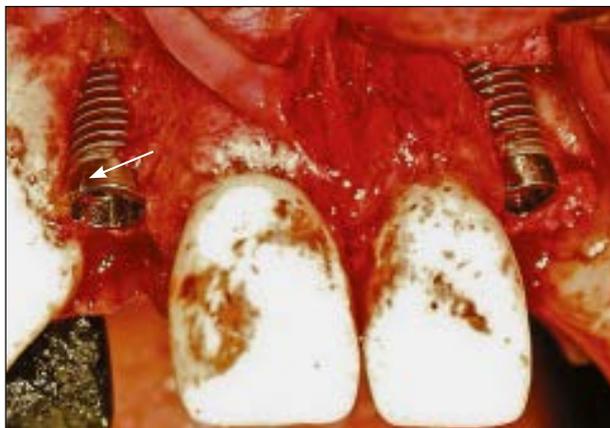
Fig 1 Clinical example of a titanium implant fractured during insertion in an undersized osteotomy created in the area of the maxillary right lateral incisor. The arrow indicates the fracture line in the region of one of the lobes forming the prosthetic interface.

insertion torques applied may either cause immediate implant fractures^{12,13} (Fig 1) or initiate a fracture process that leads to failure of the implant body following subcritical crack growth during the loading phase.¹⁴
